Analysis of Water Quality in Parkerson Mill Creek

Kerstin Glaser and Ann Ojeda

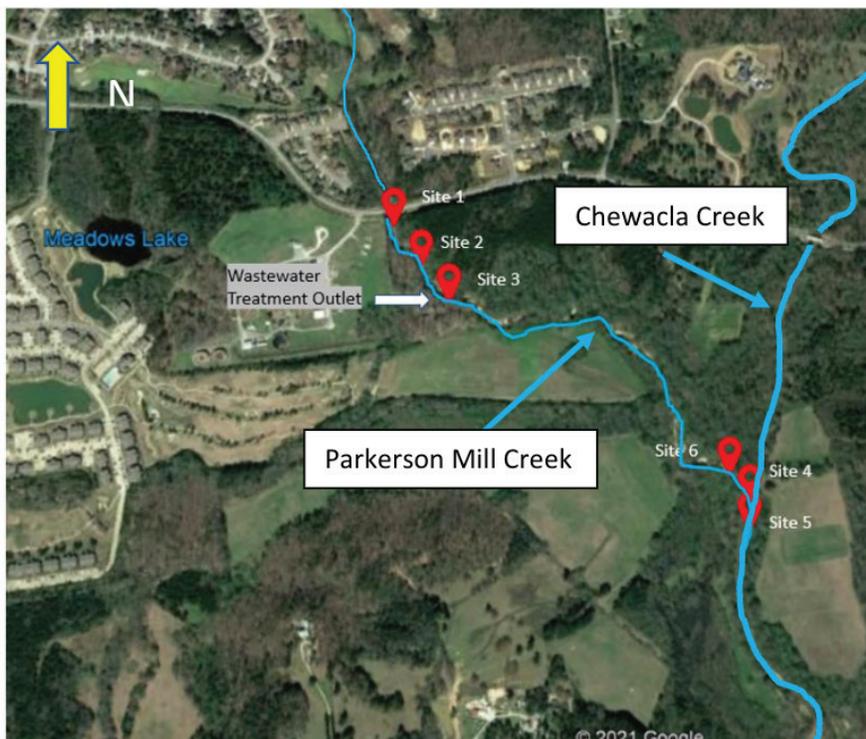
Figure 1: Sample sites for Parkerson Mill Creek. Streams are represented in blue; Sample sites are shown in red. The background layer was taken from Google Earth™.

Sample sites were selected north and south of the Chewacla Creek –Parkerson Mill Creek confluence to compare variation in water quality (Figure 1). One of the sample sites was also selected in close proximity to Auburn's wastewater treatment plant outfall into Parkerson Mill Creek. Samples were collected on 03/06/2021 and 04/09/2021.
